# ASSESSING HISTORIC TIMBER ROOF STRUCTURES

## Methodology and Case Studies from a Belgian Viewpoint

PhD, SCHUEREMANS Luc

Katholieke Universiteit Leuven, Belgium

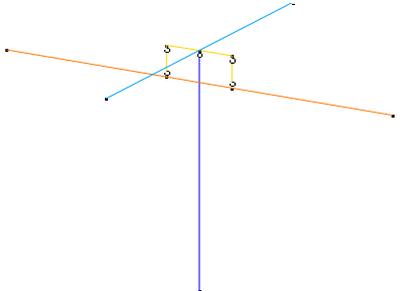
<i>Joint</i>	<i>Model</i>	<i>Example on site</i>
Connection between upper plate, collar beam and queen post

The connection between upper plate and collar beam plus queen post on the one hand and lower plate and queen post and tie beam on the other hand are modeled only to work in compression. Tensile forces are not transferred, Figure 6.

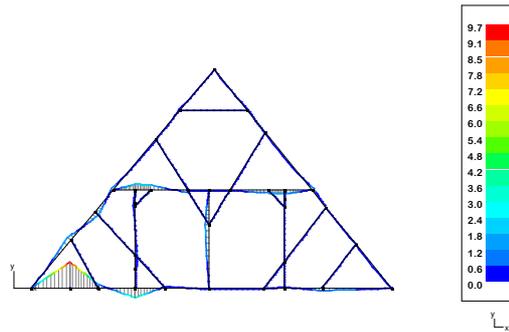
- The main structural deficiency is the presumed misconception located at the western heel joint, Figure 7, where the support does not coincide with the heel joint rafter-tie beam, resulting in increased bending moments and displacements;
- In addition, the lack of waterproofing of the roof has led to deterioration of several connections. Again this results in increased stress levels within other structural components.

**Fig. 2.** Presumed design misconception located at the western heel joint and resulting bending moment due to vertical loading (dead weight)

- Besides the classical repair as indicated for the former case study, main emphasis lies on the heel joint. A possible solution that preserves the heel joint is the insertion of a strut between the western rafter and the tie-beam in line with the western support. The efficiency of the intervention is supported by the numerical calculation, Figure 7b.
