# ASSESSING HISTORIC TIMBER ROOF STRUCTURES

## Methodology and Case Studies from a Belgian Viewpoint

PhD, SCHUEREMANS Luc

Katholieke Universiteit Leuven, Belgium

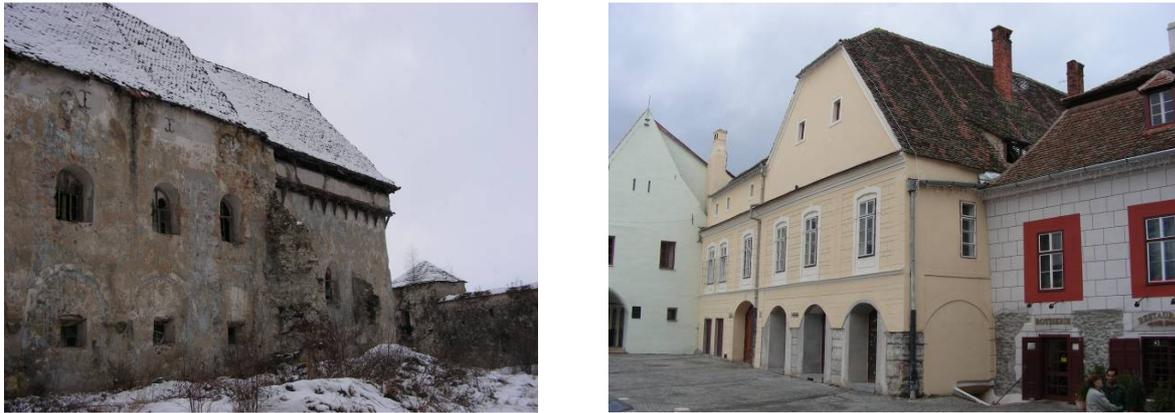
Fig.1. Romanian case studies - Church of Drăușeni and roof structure of a dwelling (block B) at the Piața Mică nr. 22 at Sibiu
